Bridger Range, Ramp
Bridger Range
MT
 Elevation: **8000 ft**
 Aspect: **NE**
 Specifics: **Ski tracks on slope; We skied slope**

Spencer Jonas
Sat Nov 11 14:45 2017
 Co-ord: **45.82853N, -110.93153W**
 Slope Angle:
 Wind Loading:

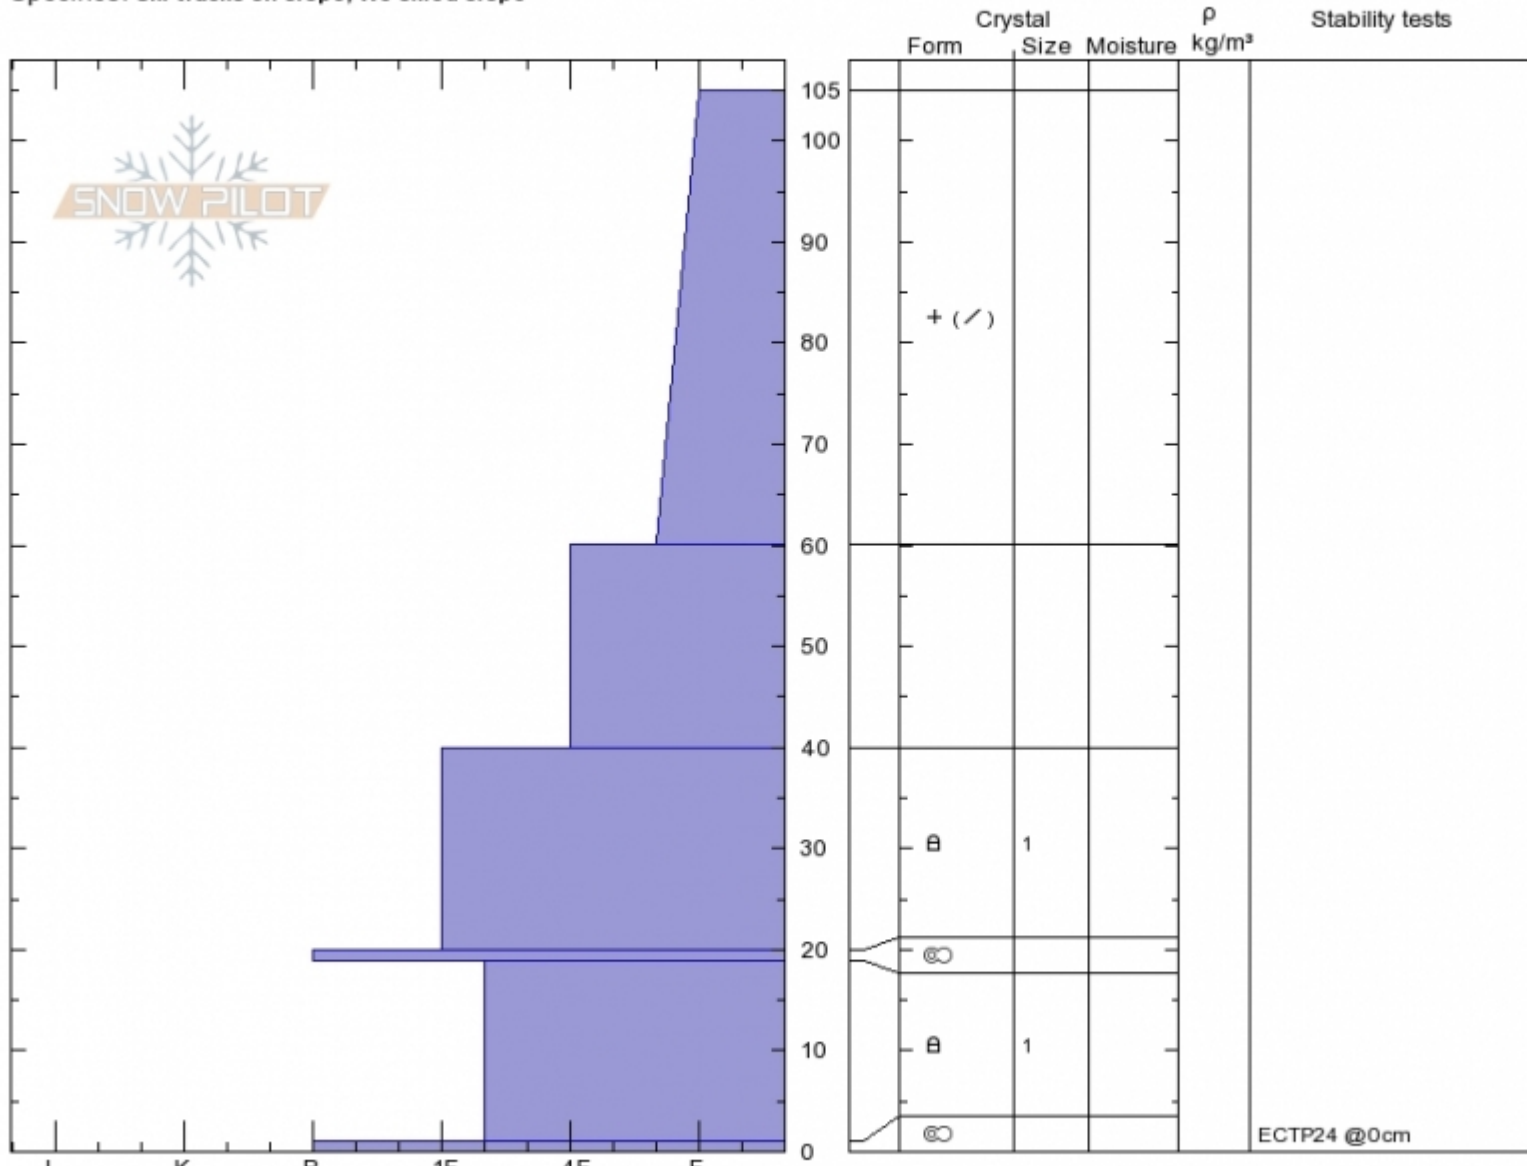
Notes: There was an air pocket between the ice crust that formed the bottom layer and the ground. The column failed when the ice broke off a little ground that it was attached to, a small root and rock at the back of the column. Our layer of concern was the old September snow. There was no sign of instability at its interface. It is hard to interpret the ectp as a sign of instability, it seemed to be more an issue of ground movement specifically beneath the column and not an indicator of overall instability at the ground.
