Advisory Region Bridger Range

Forecast link: GNFAC Avalanche Forecast for Tue Mar 26, 2013GNFAC Avalanche Advisory for Wed Mar

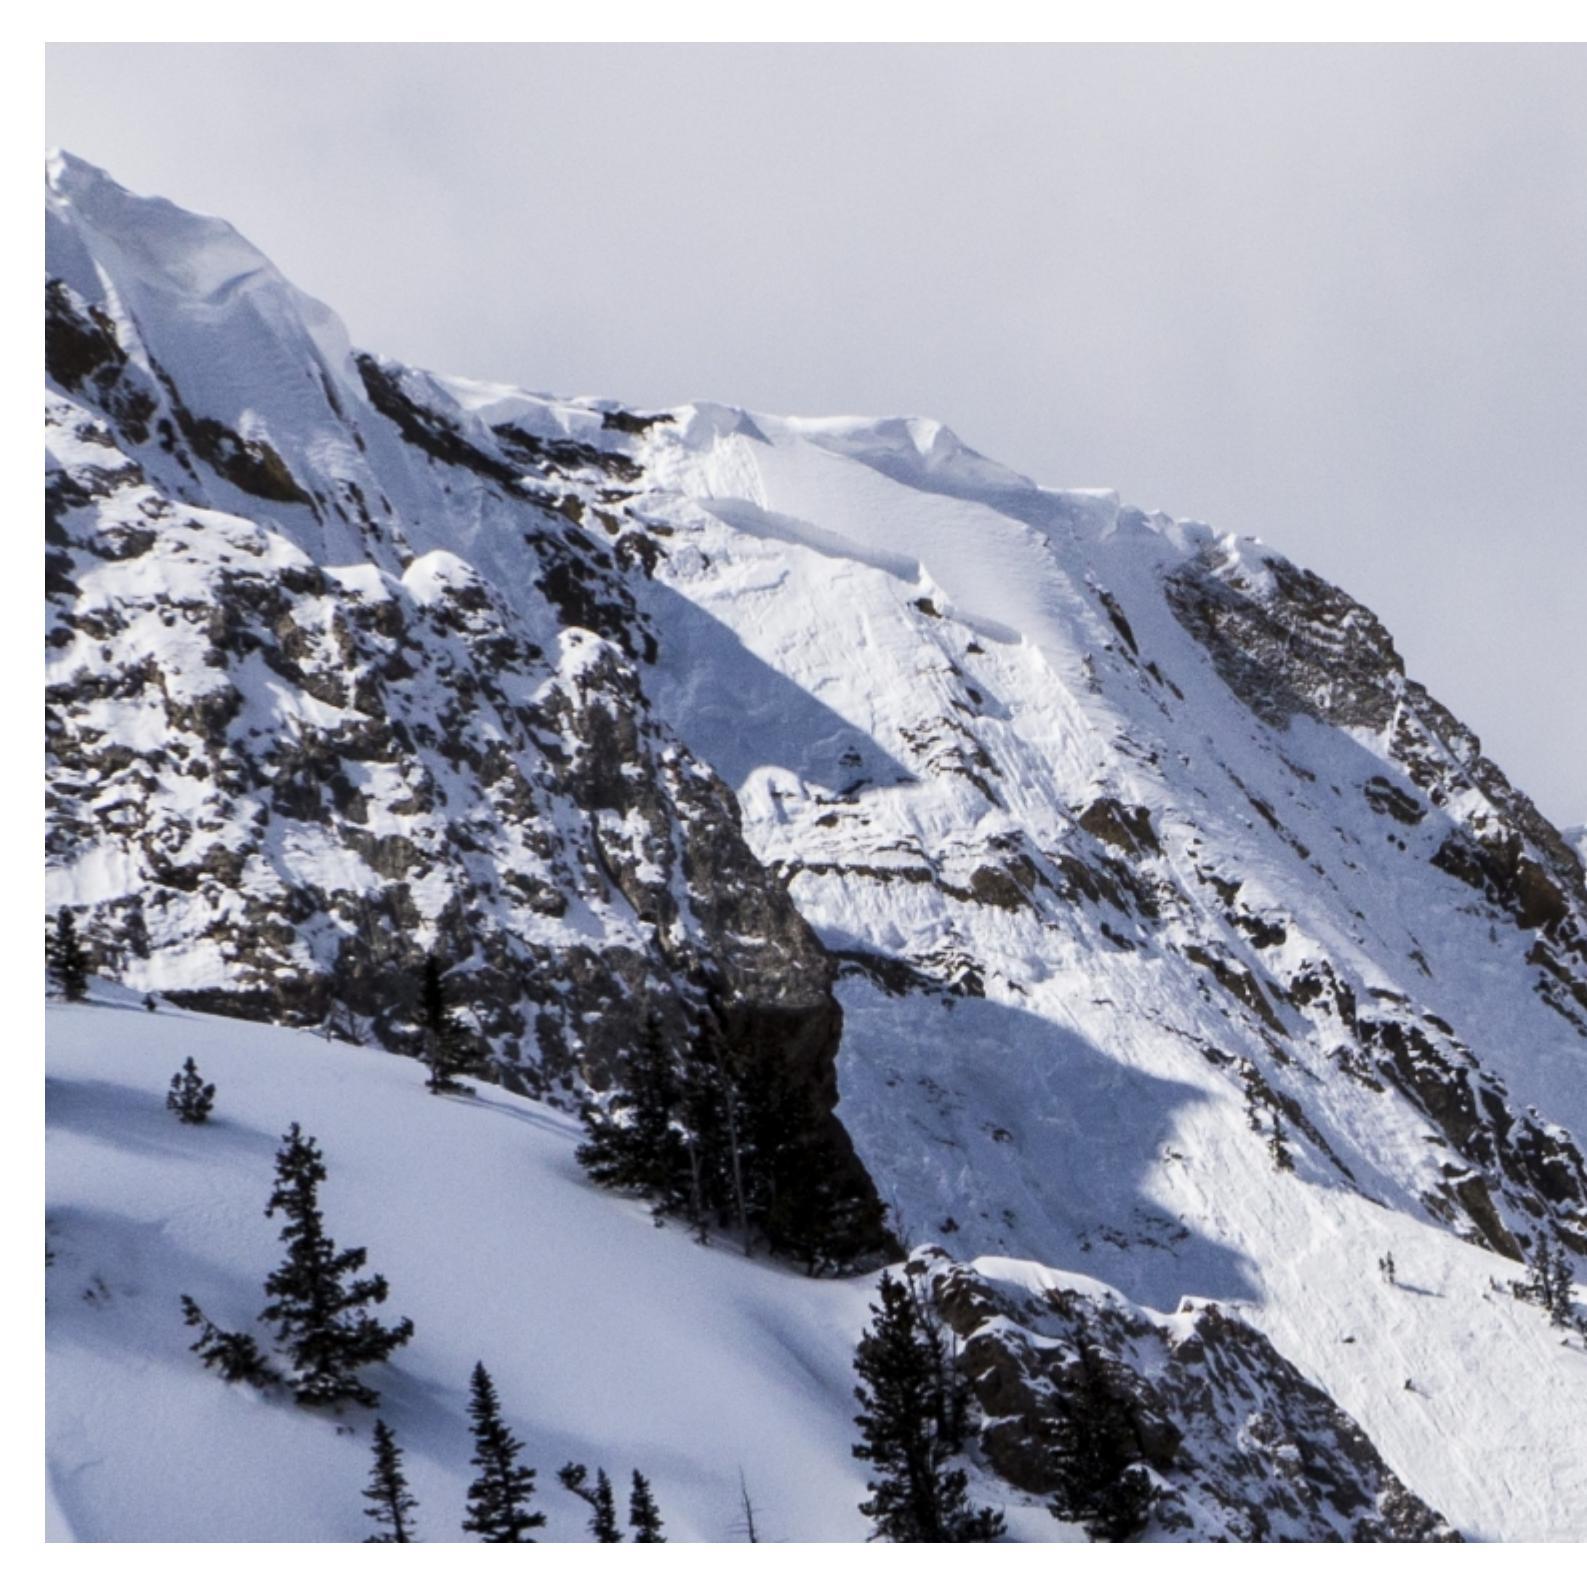
A cornice collapse triggered a steep slope in Frazier Basin in the Bridger Range. It occurred Saturday (23rd) night. After a winter of growth cornices are huge and ripe for fracturing, especially as temperatures rise above freezing. Photo: J. Kruger
